## ANTHROPOGENIC ASPECTS OF LANDSCAPE TRANSFORMATIONS

**Proceeding of Hungarian-Polish Symposium**

Edited by József Lóki & József Szabó

Debrecen 2008

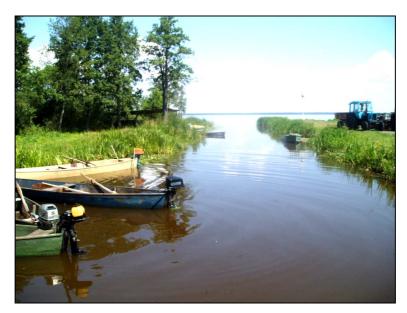
Photo. 1. Outlet of Ogiński canal from Vygonoshcha Lake (photo by. I. I. Pirozhnik)

Considering the current condition and its hydrotechnical features, the Oginski Canal can be divided into three parts (Fig. 2). In its first (western) part between the Shchara River and the Vygonoshcha lake (the distance of about 3.5 km, the difference of the water level between the Shchara and the lake is equal to 1.0 m), one of the wooden gates is preserved only. The second part – from the Vygonoshcha lake (the water level on its southern bank is at 151.8 m a.s.l.; Photo 1) up to Telekhany runs through a small lake

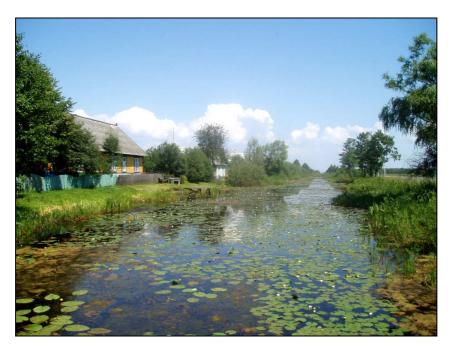
Photo 2. Oginski Canal in the Vygonoshcha village filled with water and covered with vegetation (photo by I. I. Pirozhnik)

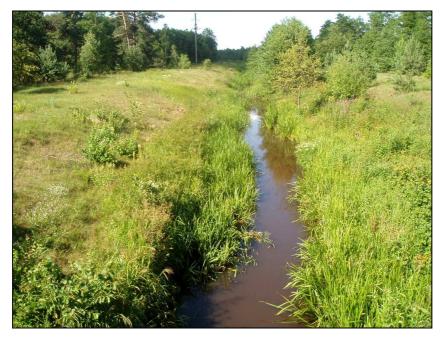
Photo 3. Shallowed canal in the north of Telekhany village (photo by I. I. Pirozhnik)

Vulka (the area  $0.51 \text{ km}^2$ , the length 1.0 km, maximum width 0.7 km). From the Vygonoshcha lake (the area 26.0 km<sup>2</sup>, the length 7.0 km, maximum width 4.8 km, the length of coast line 21.0 km, maximum depth 2.3 m) to Vygonoshcha village (5.0 km) there is sufficient amount of water in the canal, but intensive growth of water plants covers its surface (photo 2). From the Vygonoshcha village to the above mentioned Vulka lake (9.0 km) the canal goes through pine forests with some birches, it is visibly shallowed, and in some parts it dries in summer time (Photo 3).

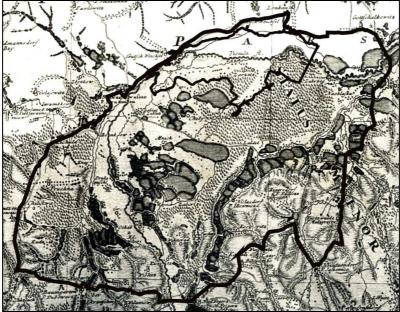
Fig. 3. Terrain management in the 1730s. in the area of present-day protection of Natura 2000 "Dolina Górnej Wisły" (after the Map of Księstwo Cieszyńskie from 1736 year by I.W. Wieland). The approximate boundary of area was marked by means of thicker external line, the range of Goczałkowice water reservoir by internal thicker line.

Varied alimentation by underground waters resulting from: different amounts of atmospheric precipitation, differences in shaping and exposure of terrain, varied possibilities of water retention in the catchment, lasting since the Middle Ages transformations of water relations (Fig.1, 2 and 3) is the cause of lability of water stages and discharges in the Vistula and its tributaries. Water stages fluctuate within the range from a dozen or so up to tens of centimetres, and the discharges amount on an average to from some decimal <sup>3</sup>/s in small streams to some m<sup>3</sup>/s in the case of the Vistula flowing from the Goczałkowice water reservoir.

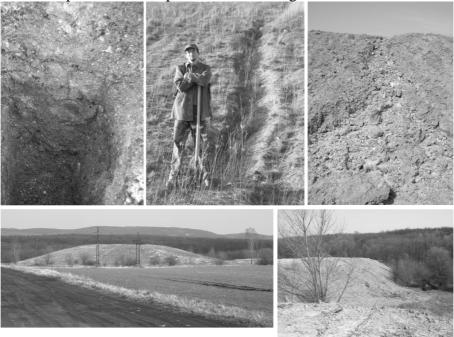
Fig. 9. *Upper row* (from the left to the right: the "soil" of the heap; erosional gully with vegetation cover; renewal of erosional gullies after the illegal planation works *Bottom row* (from the left to the right): the heap, the woodland and the Vértes Mts.; illegal planation works near the protected area

Since the heap itself is dry, it is not consolidated by the reworking activity of the water only by its own weight. The owners committed several mistakes when they decided to recultivate the heap again. First, without any permission they initiated landscaping fieldworks. Using heavy engines they accidentally cut through eletric wires leaving the part of Oroszlány town without electricity. They cut down forests near the creek and tried to plane the surroundings of the heap illegally, ruining the vegetation and modifying the runoff and the condition of stabilised slopes. The optimal cost-effective recultivation plan for the heap can be seen on Fig. 9-10.

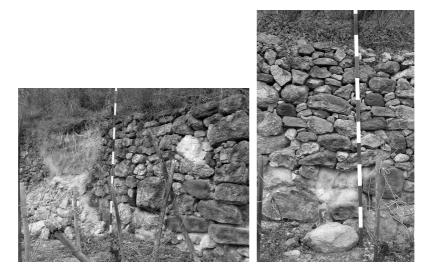
2. Block pushed out from the wall-belly at the bottom of the supporting walls (120 cm)

from 25% to 84% of total wall breaks. The length of the significant destructions is between 2-13 m. Having indicated a chain-reaction, after the dilapidation the process will take place at the nearby wall-belly.

At long-time abandoned terraces the mechanical force of root pressure can also generate the occurrence of the wall-belly and wall breaks.

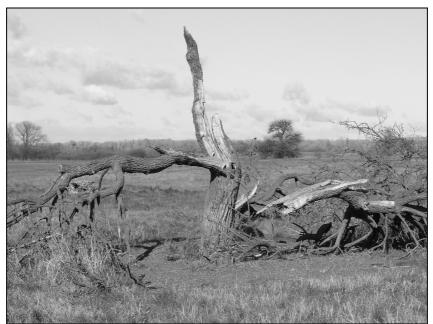
Photo 2.: One of the numerous dead wild pear trees found in the model area, probably dried up due to fungal infection (photograph by Csaba Tóth, 2007)

The health status of living specimens raises concerns. Damage sources and pathological factors are often interconnected, creating the necessary conditions for one another and resulting in so-called damage chains (Tompa, 1975, Pápai, 1999). It would be very difficult to identify the mechanisms of these primary and secondary damage factors, or their positive and negative effects on each other. Such an examination is out of the scope of the present study. Nearly all specimens showed some dead parts or missing wood (e.g. dead branches, branch stumps, hollows, cavities, gaps under detached barks etc.), therefore, in the absence of quantitative indicators, the number of specimens affected by various types of damage and that of healthy specimens were estimated. Damage by the abiotic environment (wind, lightning etc.), biotic damage (insects, fungi) and mechanical damage caused by human activity affected 11, 38 and 16 trees, respectively. The remaining 123 specimens (65.4 %) can be regarded as healthy. In declining dry oak woods, wild pear usually grows together with the characteristic shrub species of the accompanying community, such as blackthorn (16 pcs), hawthorn (12 pcs) and wild rose (20 pcs), therefore it has an important role in the secondary succession of woody communities (Gencsi–Vancsura 1992). Within a circle having a radius of 10 m around the specimens, the following tree species were found: *Elaeagnus angustifolia L*., (3 pcs, planted during alkaline soil afforestation), elder (4 pcs), *Ulmus laevis* (2 pcs), as well as wild apple, mulberry, *Celtis occidentalis* and grey poplar (1 pc each).

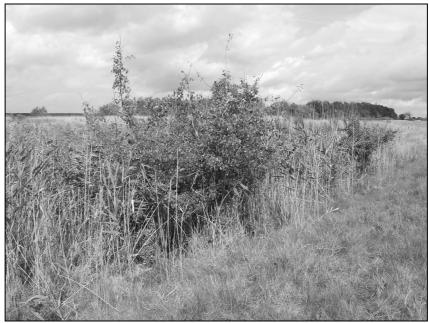
Photo 3.: Several young wild pear specimens were found on the edges of marshy patches in Bokros-puszta (photograph by Csaba Tóth, 2007)

found in the case of nearly three fourths (146 pcs, 72.3 %) of the stock. The young specimens found in swales and on point bar slopes (consisting of deposit whose fineness increases in an upwards direction) emerged naturally, probably through seed germination (Photo 3.).
