Article

Microscopic Identification of 24 Timber Samples Obtained from Half-Timber Walls in Northern Spain—Considerations on the Relationship between Species and Constructive Needs

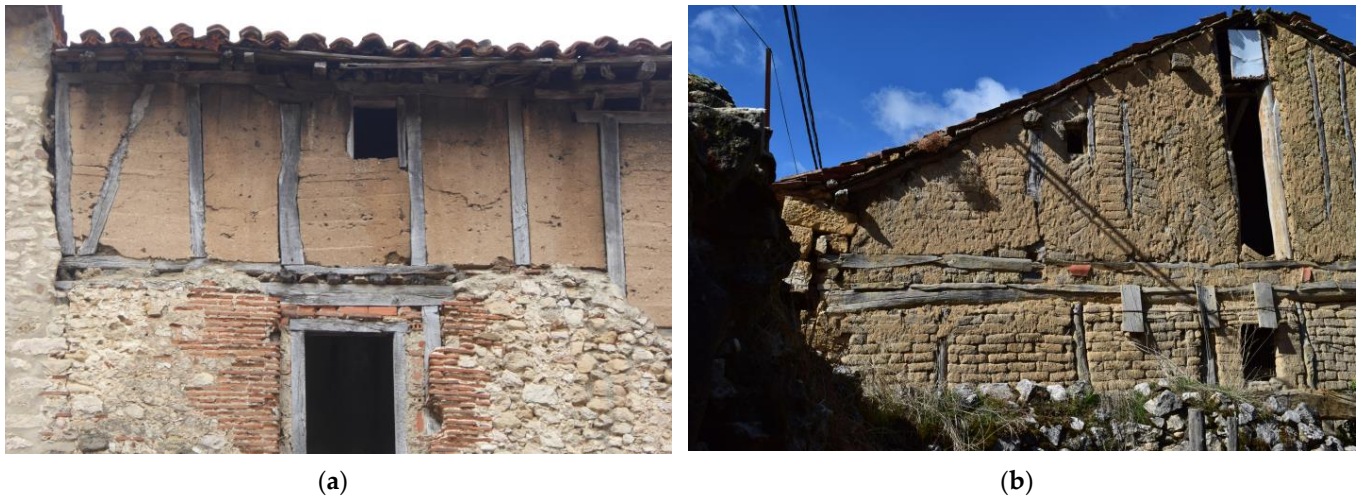
Figure 1. Examples of half-timber walls with heavy infills: (a) monolithic infill of gypsum concrete in Pancorbo (Burgos); (b) masonry infill of adobe infill in Moral de Hornuez (Segovia).

have been classified according to the associated constructive logic, grouped into monolithic infills relating to the use of formwork (Figure 1a); masonry infills stacking pieces that were carved beforehand (Figure 1b); lightweight rigid screens made up of laths, boards, or other firm elements (Figure 2a); finally, flexible screens built with malleable plant elements such as branches, wattle, or reeds (Figure 2b).

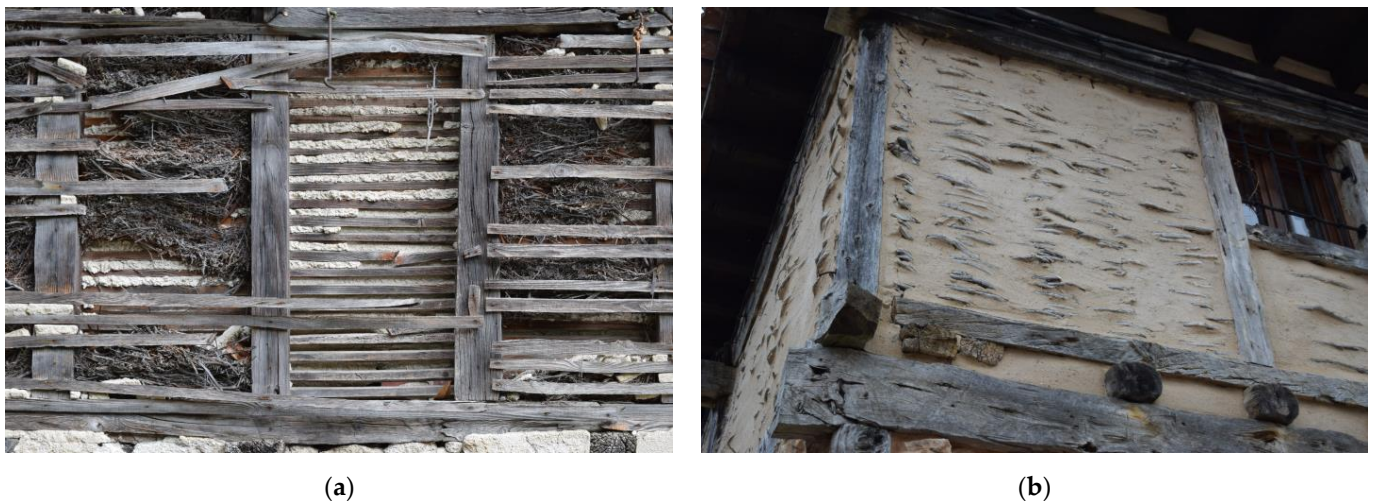
Figure 2. Examples of half-timber walls with lightweight screens: (a) rigid screens of lath-and-daub in As Ermidas (Ourense); (b) flexible screen of wattle-and-daub in Calatañazor (Soria).

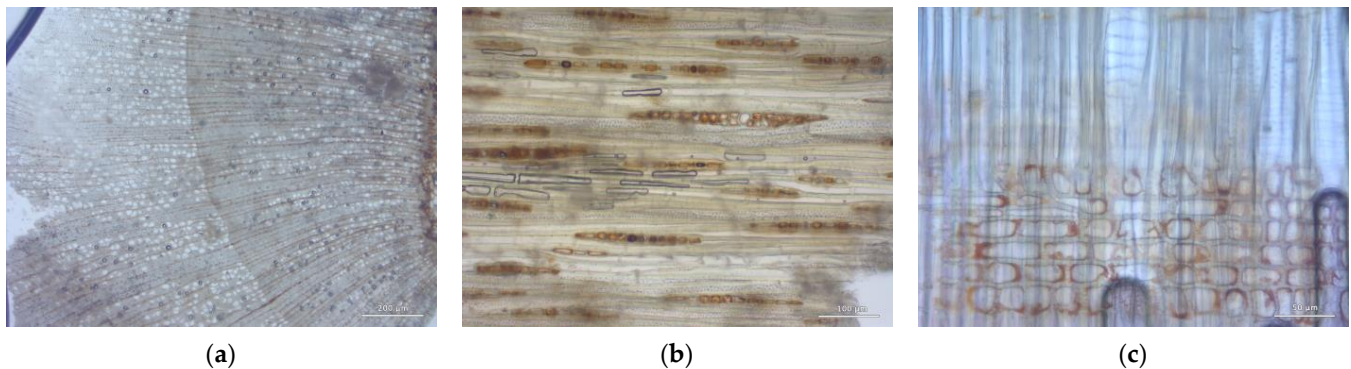
Figure 4. Characteristic sections identified as belonging to the *Corylus* genus: (a) Cross-section of sample AS3; (b) Tangential section of sample CA1; (c) Radial section of sample CA1.

Samples AS1, AS3, and CA1 were identified as belonging to the *Corylus* group based on the presence of rings with diffuse porosity, radially grouped pores, rings with slightly undulating growth, greatly diffuse apotracheal parenchyma, aggregated rays made up of heterogeneous biseriate or triseriate rays with a height of 10–15 cells, as well as scalariform perforations with a maximum of 5 to 10 highly distinctive bars (Figure 4) [41].

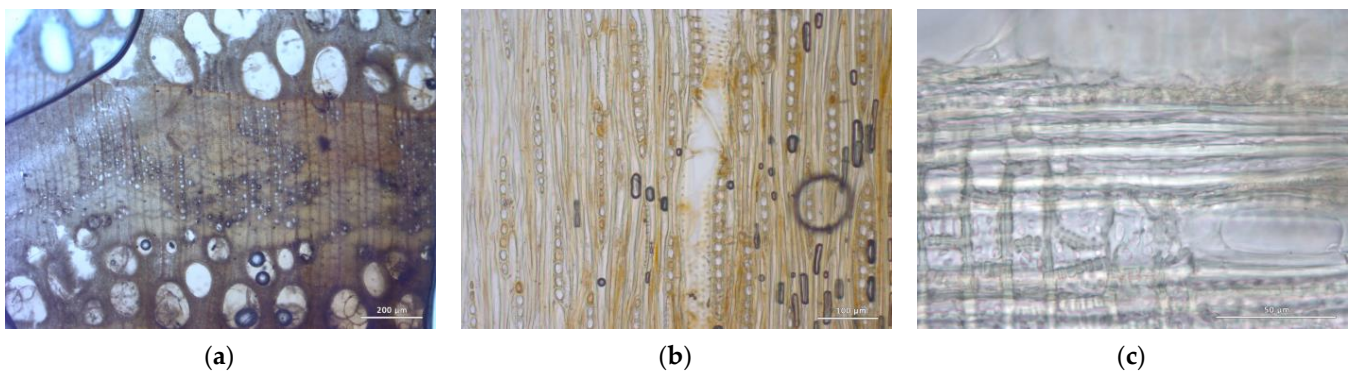
Figure 6. Characteristic sections identified as belonging to the species *Castanea sativa* Miller: (a) Cross-section of sample L3b; (b) Tangential section of sample LU1a; (c) Radial section of sample AS2.

Samples AS2, AS4, LE3a, LE3b, and LU1a have been identified as belonging to the species *Castanea sativa* Miller, commonly known as the chestnut tree. The most relevant characteristics for this were the existence of porous rings with vessels in dendritic radial patterns, the presence of vasicentric tracheids, and homogeneous uniseriate rays with procumbent cells with a mean length between 10 and 30 cells, as well as the presence of tylosis in some vessels (Figure 6). The main difference in relation to the *Quercus* genus is the absence of wide multiseriate rays [41]. Specifically, sample AS2 is a relatively young branch where fundamental microscopic characteristics were not fully developed, particularly with regard to the dendritic radial arrangements with large vessels making up a visible porous ring. Therefore, in order to confirm the hypothesis, the sample was compared against other documented samples to show that young branches may not display this characteristic as prominently [45].

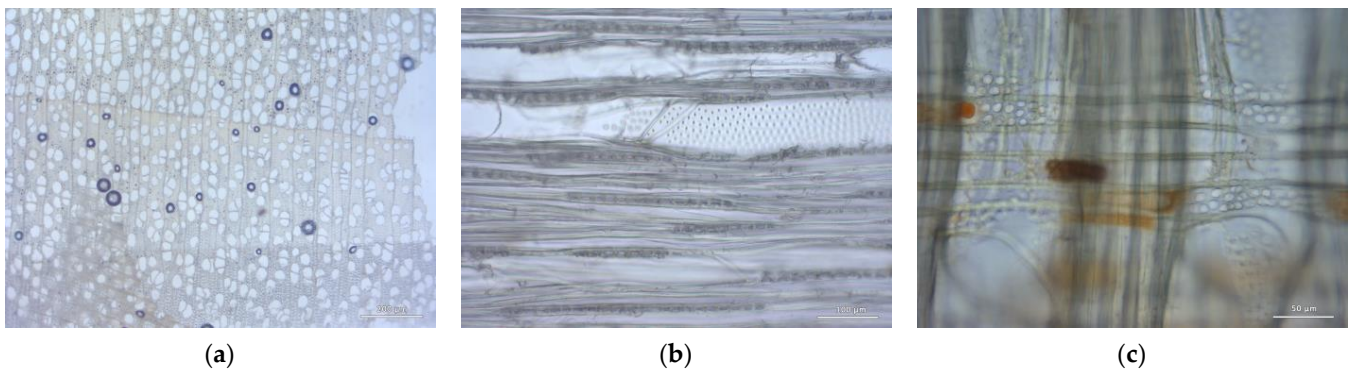
Figure 8. Characteristic sections identified as belonging to the *Populus* genus: (a) Cross-section of sample BU1; (b) Tangential section of sample CA2; (c) Radial section of sample PA1.

Samples BU1, CA2, RI1, PA1, and SE1 were microscopically identified as belonging to the *Populus* group of broadleaf, where the different species cannot be distinguished, based on their microscopic characteristics. The main identification features observed were the presence of diffuse- to semi-ring-porous, uniseriate, and homogeneous rays between 10 and 15 cells long, vessels with simple perforations and no helical thickening, and cross-fields with simple and large pits (Figure 8) [41].

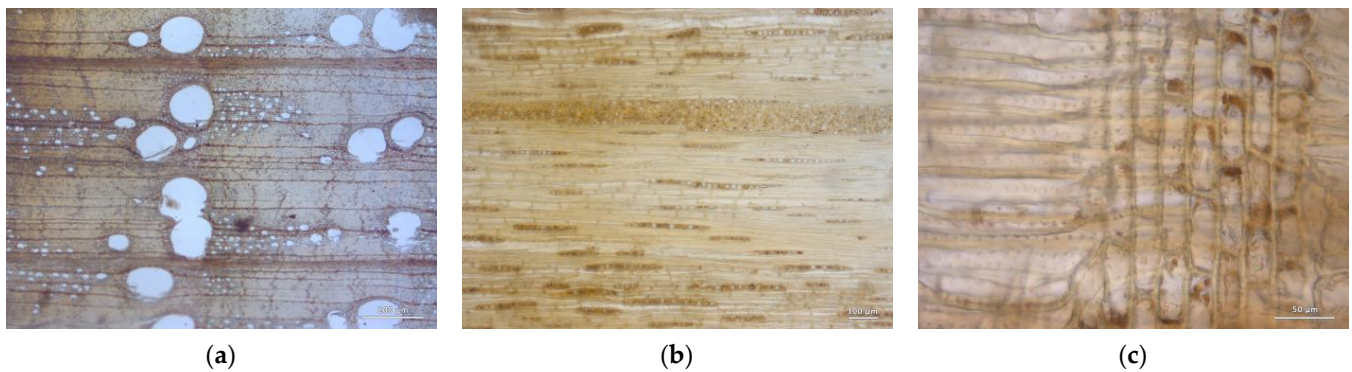
Figure 10. Characteristic sections identified as belonging to the *Quercus* genus: (a) Transversal section of sample PA2; (b) Longitudinal section of sample LE2; (c) Radial section of sample RI3.

Samples PA2, LE2, and RI3 have been identified as belonging to the *Quercus* genus, due to the presence of porous rings with vessels in dendritic patterns, apotracheal parenchyma in bands, and multiseriate rays visible to the naked eye along with unicellular rays (Figure 10) [41].

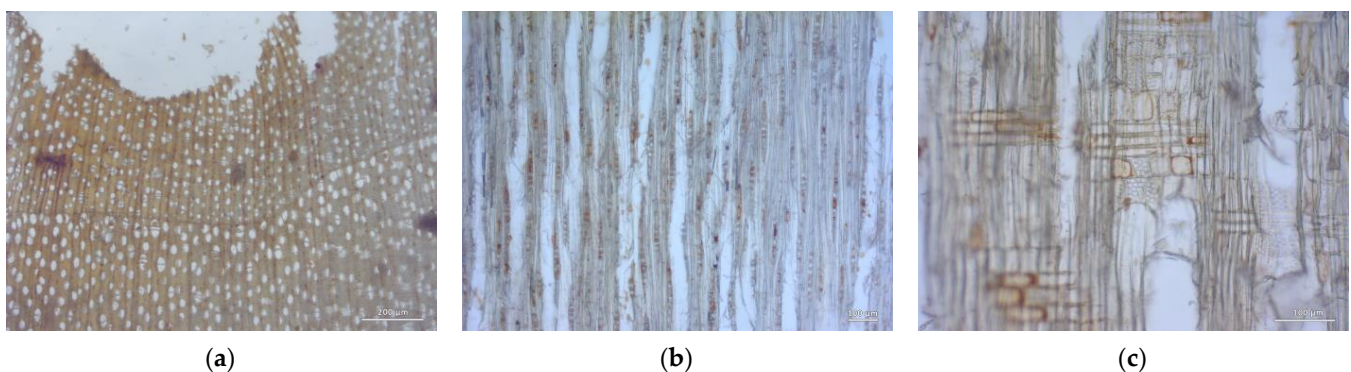
Figure 12. Characteristic sections identified as belonging to the *Salix* genus: (a) Transversal section of sample LU1b; (b) Longitudinal section of sample LU1b; (c) Radial section of sample LU1b.

Only sample LU1b has been identified as belonging to the *Salix* genus, specifically in an encastada screen located in Peites (Lugo). The main features observed were the presence diffuse- to semi-ring-porous wood, uniseriate and heterogeneous rays with a mean height of between 10 and 15 cells made up of several rows of square cells combined with marginal rows of slightly vertical cells, simple perforations, and wide and simple pitting of the cross-fields (Figure 12) [41].

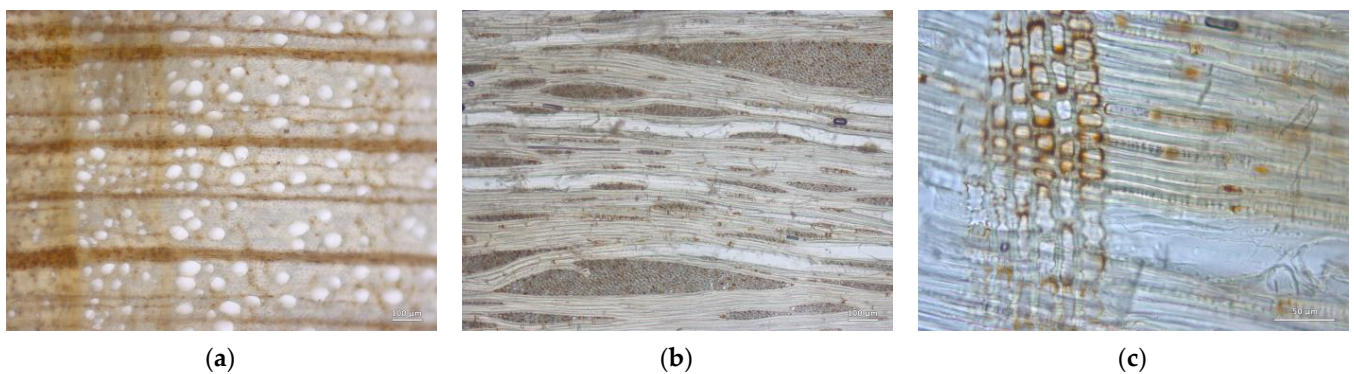
Figure 14. Characteristic sections of sample RI2 identified as belonging to the *Fagus* genus: (a) Cross-section; (b) Tangential section; (c) Radial section.

Sample RI2, extracted from the beam of a half-timber wall located in Poyales (La Rioja), was the only one identified as belonging to the *Fagus* species group. The features observed were mostly the presence of diffuse-porous to semi-ring-porous, grouped vessels in the earlywood and isolated vessels in the latewood, and the existence of homocellular rays both in multicellular groups visible to the naked eye and in unicellular ones (Figure 14) [41]. Although initially it is not possible to establish an anatomical distinction for *Fagus sylvatica* L. and *Fagus orientalis* Lipsky, the latter can be ruled out as it is not found in Spain (Figure 15) [42]. The species *Fagus sylvatica* L., or common beech, has a long trunk 30 to 35 m high and up to 1 m in diameter, with medium-density and medium-resistance timber [44]. It generally displays low durability due to fungi, termites, and fine woodworm, although in the specific case of fine woodworm, it increases in the duramen.

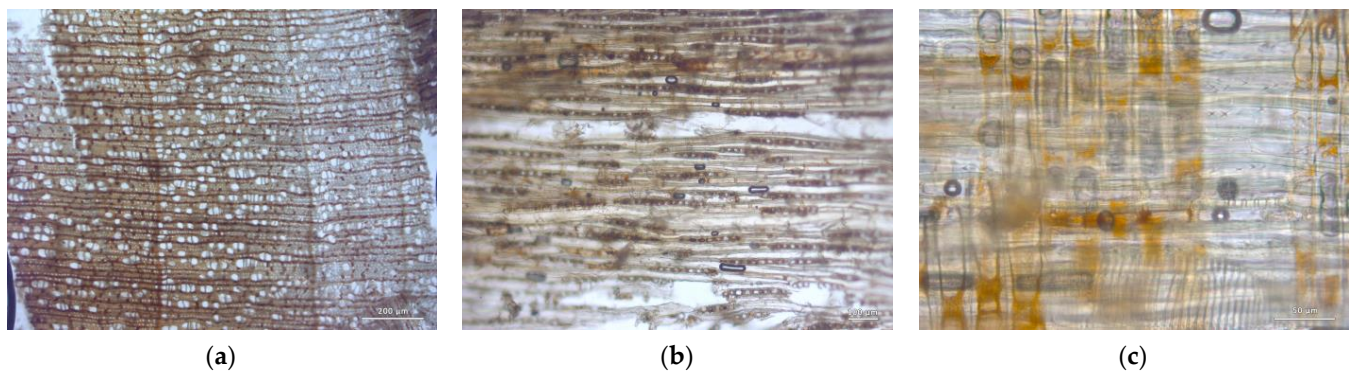
Figure 16. Characteristic sections of sample LE1 identified as belonging to the *Alnus* genus: (a) Cross-section; (b) Tangential section; (c) Radial section.

The only sample identified as belonging to the *Alnus* genus is LE1, taken from the lath of a lath-and-daub enclosure of a half-timber wall in Almagarinos (León). These have been identified through the features, mostly the presence of diffuse to semi-ring-porous with vessels in radial groups, the presence of uniseriate homogeneous rays up to 25 cells long, as well as scalariform perforations of over 20 bars (Figure 16) [41]. These last two characteristics are the main distinguishing factors between this genus and the samples belonging to the genus *Corylus*, where the rays are heterogeneous and the bars of the scalariform perforations are limited to 5 or 10. At the microscopic level, it is not possible to distinguish between the species *Alnus cordata* Loisel, *Alnus orientalis* Decaisne, *Alnus incana* L., and *Alnus glutinosa* L., although, given that the latter is the only species documented in Spain, the others can be ruled out (Figure 17). The species *Alnus glutinosa* L., alder, is characteristically found in Spain and has a slightly irregular trunk that tends to be around 30 cm thick and 10–12 m high [44]. This hardwood timber has a relatively low structural resistance, and is low density, so it is relatively easy to execute unions using nails, screws, and other metal elements. However, in general, its durability is very low and it is very susceptible to rot, although it noticeably improves when permanently submerged.

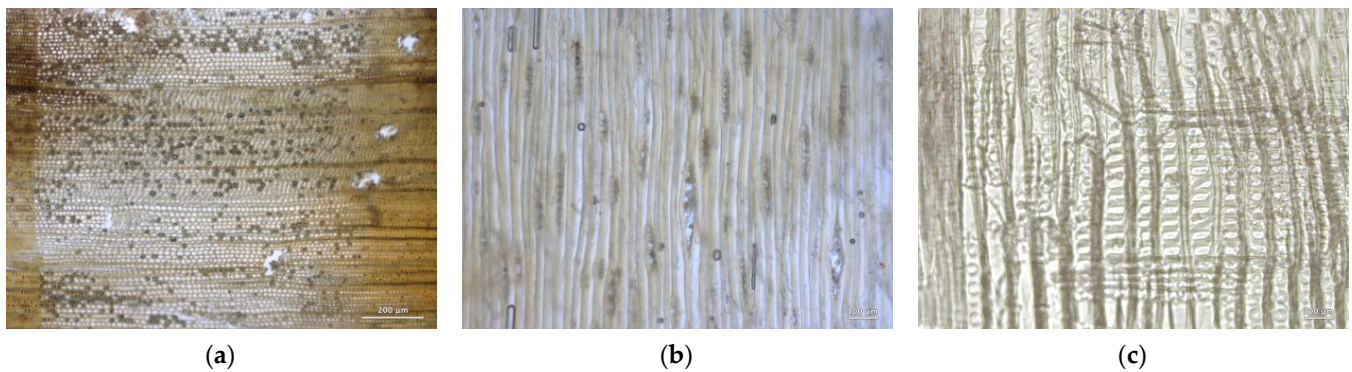
Figure 18. Characteristic sections identified as belonging to the species *Pinus sylvestris* L.: (a) Cross-section of sample BU2; (b) Tangential section of sample BU2; (c) Radial section of sample TE1.

Samples BU2 and TE1 have been identified as belonging to the *Pinus sylvestris* L. and *Pinus mugo* Turra species groups, which cannot be clearly distinguished at an anatomical level [41]. The features observed were the presence of resin ducts with thin epithelial cell walls and the presence of resin ducts within rays, heterocellular rays with a mean height of 8 to 15 cells, large fenestriform pitting of cross-fields, and strongly serrated walls on the radial tracheids (Figure 18) [41]. However, considering the absence of *Pinus mugo* Turra in the Iberian Peninsula, it could be assumed that these samples probably belong to the species *Pinus sylvestris* L. (Figure 19) [42], commonly known as Scots pine. This wood is characterised by a straight trunk with few branches, medium density, medium resistance, and hygroscopicity and a limited durability to rot, termites, and woodworms [49].

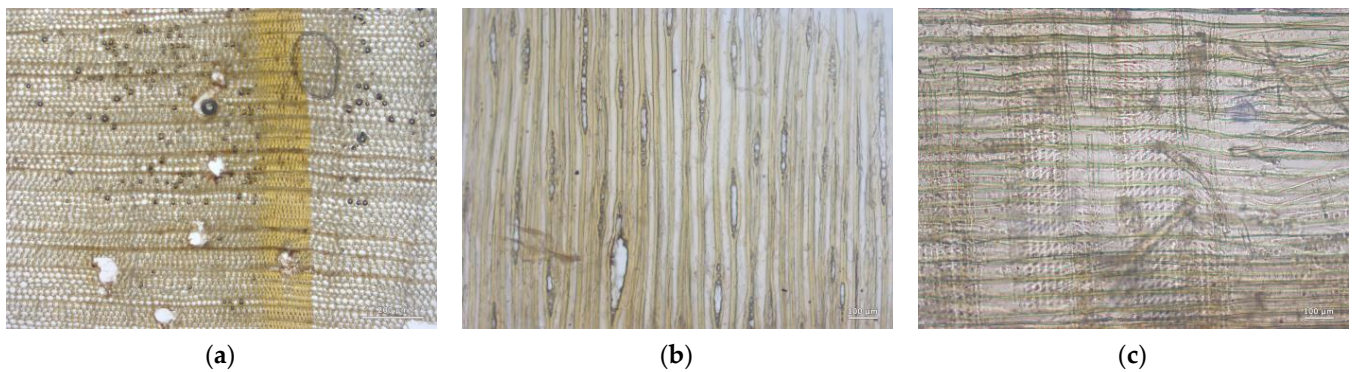
Figure 20. Characteristic sections identified as belonging to the species *Pinus pinaster* Aiton: (a) Cross-section of sample OU1; (b) Tangential section of sample OU1; (c) Radial section of sample OU2.

Samples OU1 and OU2 have been identified as belonging to the species *Pinus pinaster* Aiton based on the presence of relatively large resin ducts with thin-wall epithelial cells, heterocellular rays with a mean height of 10 cells, small pinoid to taxodioid pitting in the cross-fields, and the clearly serrated walls of radial tracheids (Figure 20) [41]. The timber of this species, known as maritime pine, displays a characteristically light density, a hygroscopicity that tends to be low, and medium structural resistance [49]. While the duramen displays considerable resistance to rot fungi, termites, and xylophagous insects, the sapwood is highly susceptible to this type of degradation. In both cases, these samples (OU1 in Biobra (Ourense) and OU2 in Manzaneda (Ourense)) are vertical structural elements from the half-timber walls with lath-and-daub enclosures (Figure 21).

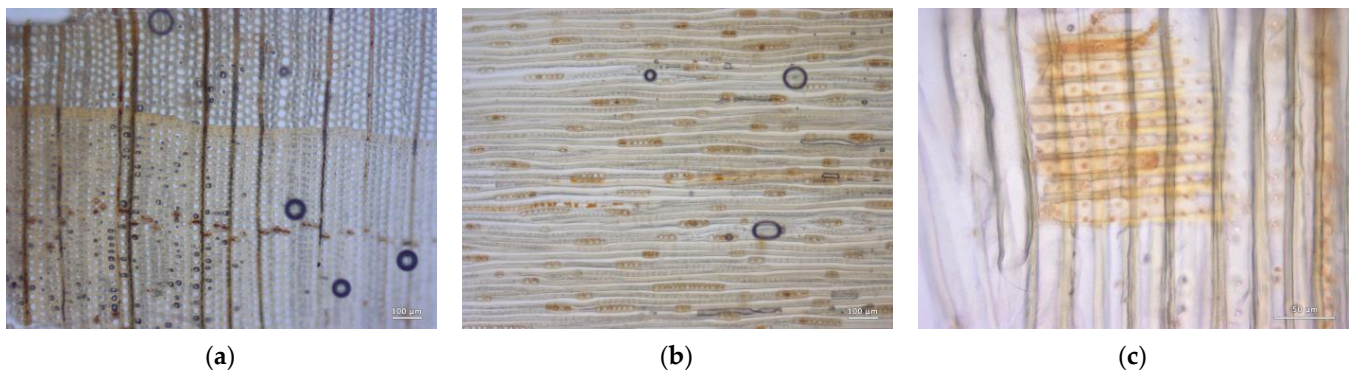
Figure 22. Sections characteristic of sample SO1, identified as belonging to the *Juniperus* genus: (a) Cross-section; (b) Tangential section; (c) Radial section.

The only example identified as belonging to the *Juniperus* genus is sample SO1, extracted from the upright of a building in Rejas de San Esteban (Soria). The microscopic characteristics relevant to its identification were the absence of resin ducts, axial and radial parenchyma cells with brown substances, homocellular rays with a mean height of between 2 and 5 cells, cupressoid pits, and nodular walls between ray cells (Figure 22) [41]. On a microscopic level, it is not possible to distinguish between the species that make up this genus. However, from analysis of the species found in Spain [42] and their characteristics, it can be assumed that this is *Juniperus thurifera* L., as the other species found in the Spanish climate are generally shrublike and not always suited to construction (Figure 23). Equally, the available documentation suggests that there was a traditionally widespread use for construction in the region of *Juniperus thurifera* L. wood [50,51], although Spanish juniper is

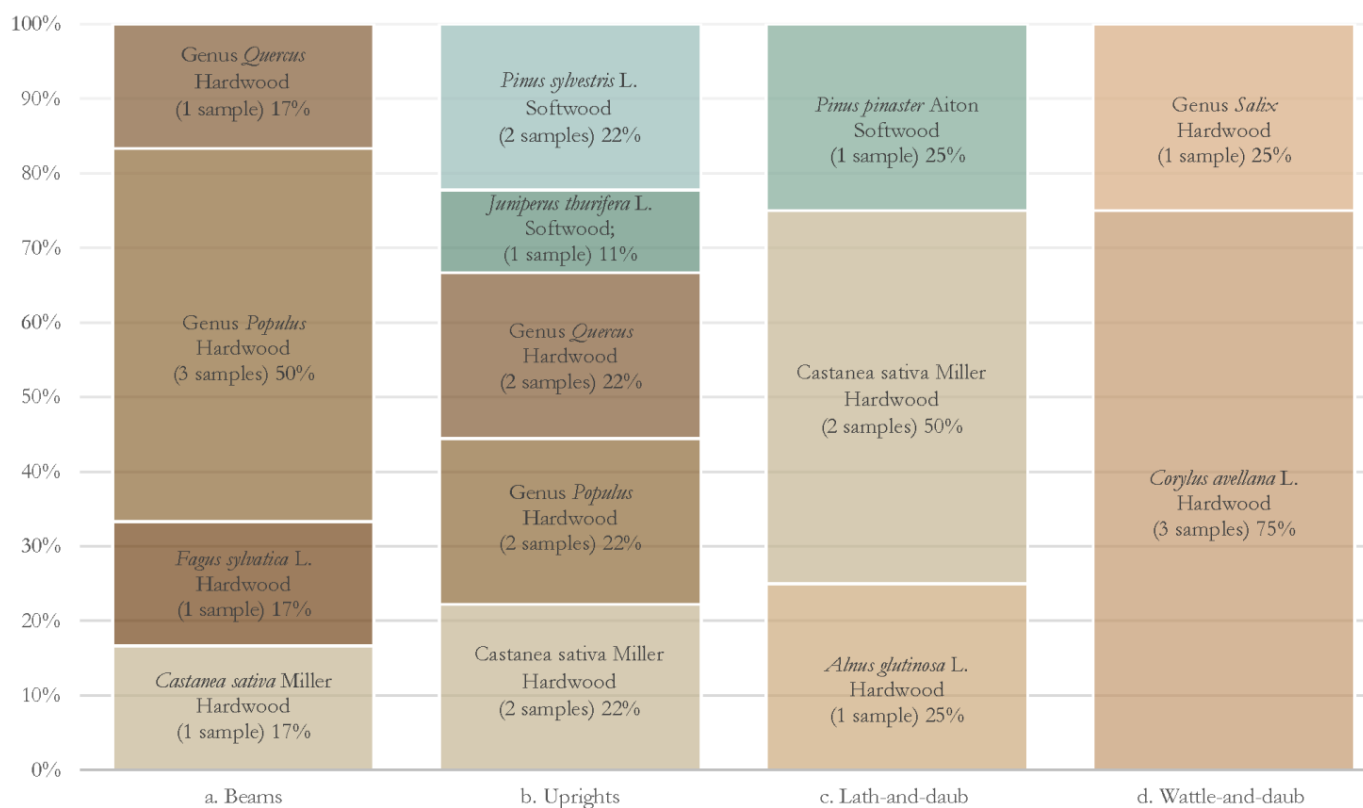
Figure 24. Distribution of the different species identified based on their presence in structural elements such as beams and uprights or in enclosure elements such as laths or flexible rods.

on whether they are used for structural elements such as uprights or beams or whether they are laths or rods used in the construction of the enclosure of the framework (Figure 24).

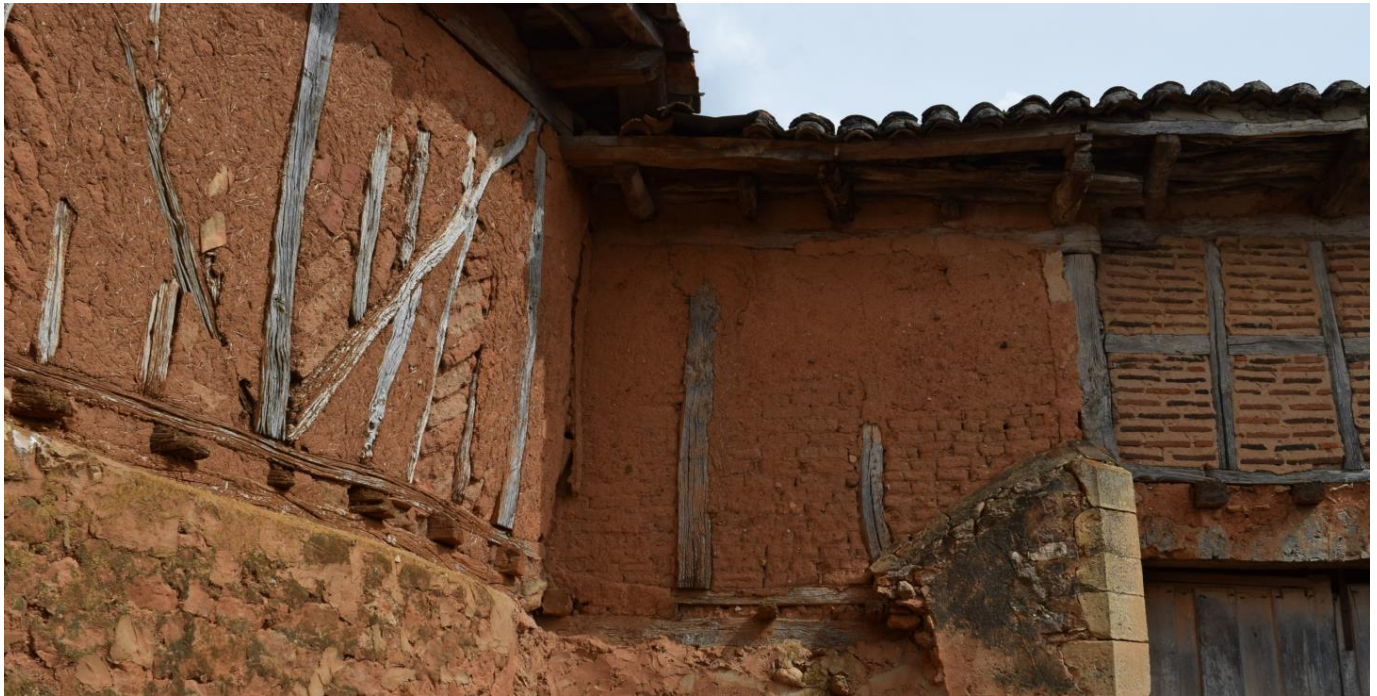
Figure 25. Half-timber wall with heavy adobe filling, where the wood used for the construction of the framework must meet minimum mechanical resistance requirements. Building located in Pedro de Ojeda (Palencia), with the sample PA1 analysed and identified as belonging to the *Populus* genus.

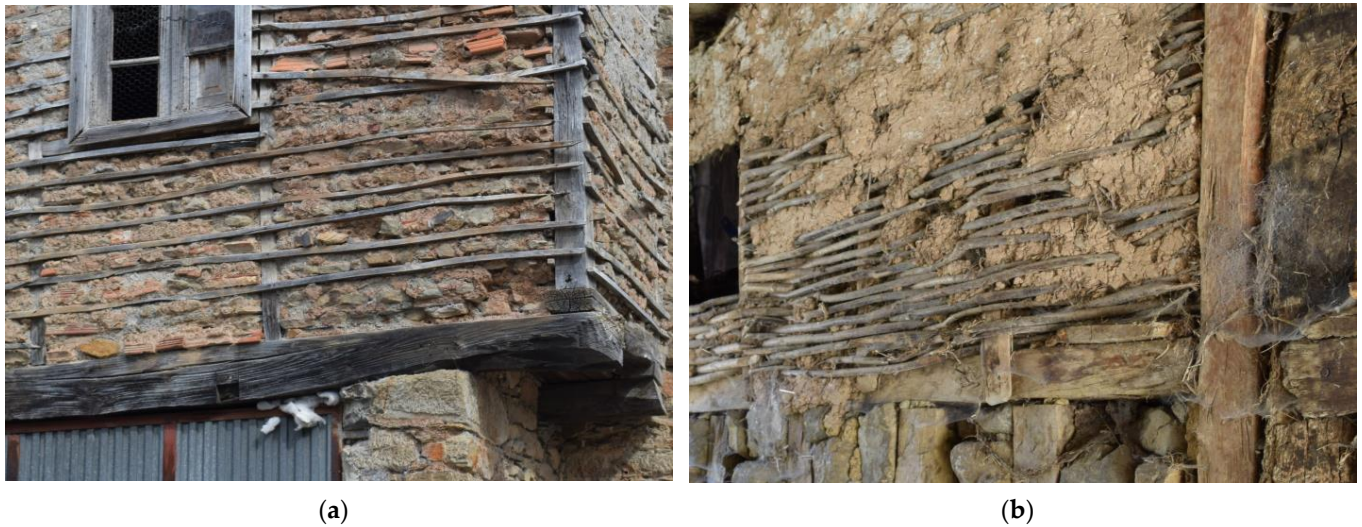
Figure 26. Half-timber walls with lightweight enclosures executed using wooden elements: (a) lath-and-daub enclosure with laths identified as *Alnus glutinosa* L. in Almagarinos (León); (b) Wattle-and-daub enclosure with flexible rods identified as *Corylus avellana* L. in Caloca (Cantabria).

In the case of rigid screens, there are documented examples of timber with relatively high structural resistance such as *Pinus pinaster* Aiton and *Castanea sativa* Miller, as well as examples of *Alnus glutinosa* L. with its characteristic low structural resistance. In any case, its use for laths of the lath-and-daub does not require good mechanical behaviour in principle, as it does not act simply as an enclosure and, therefore, is presumably not a factor to consider when selecting a given species. These examples of lath-and-daub are executed by nailing or fitting laths to form single or double panels that could be rendered or filled in with other materials, so it is preferable to use branches or elements rigid enough to withstand this filling (Figure 26a). Examples of the *Salix* genus and the *Corylus avellana* L. species have been documented in the execution of wattle-and-daub screens. The young branches of these species are extremely flexible so that they can be braided around an auxiliary timber substructure, a solution that would be impossible with more rigid branches (Figure 26b).
