DE-ICING SALTS, SALT-TOLERANT VEGETATION AND CALCIUM SULFATE

3. Title and Subtitle Deicing Salts, Salt-tolerant Vegetation and Calcium Sulfate

6. Performing Organization Report No.
UMTC-03-01

Final Report

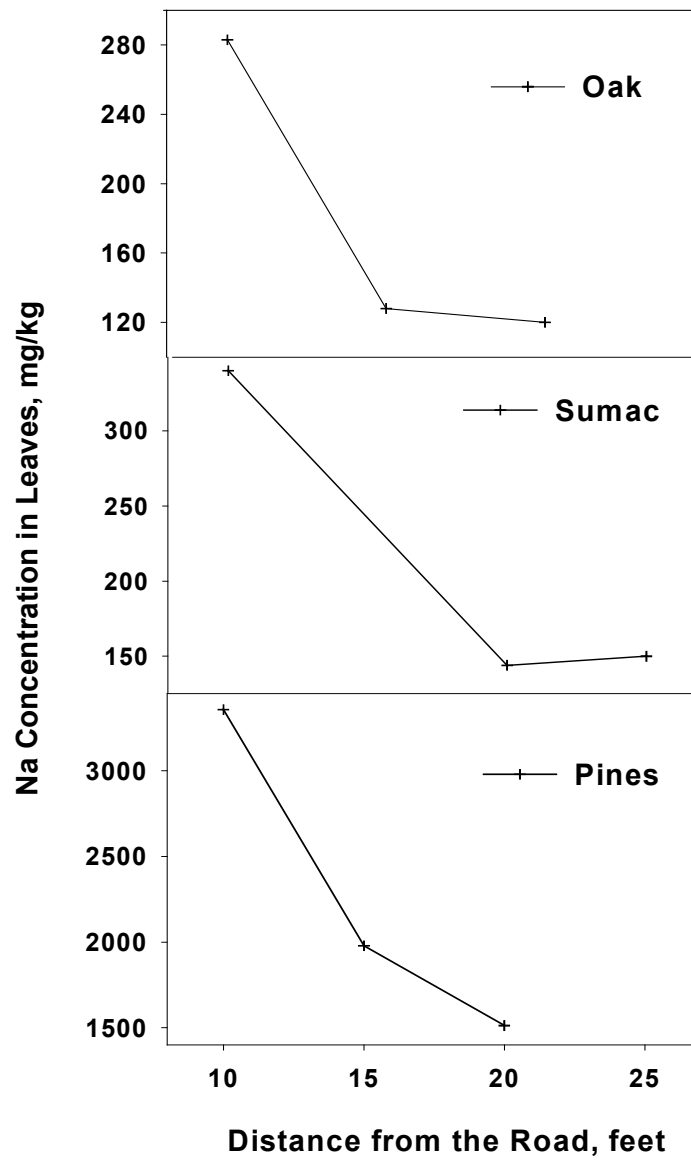
Figure 3-1. Mean Sodium Concentration in Leaves of Oaks, Sumac, and Pines as a Function of Distance from the Road Pavement

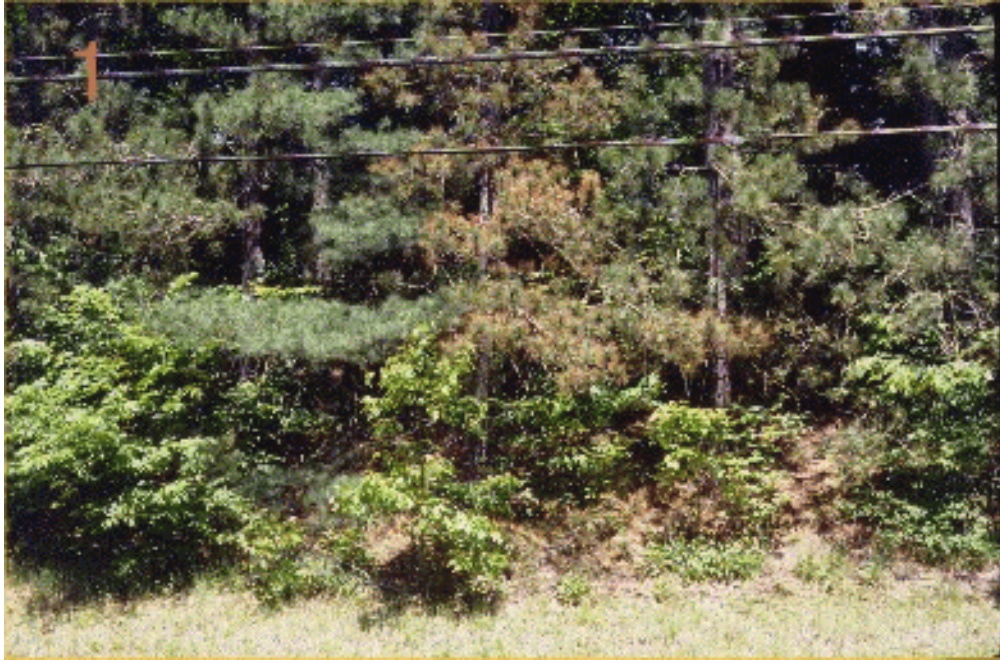
1. Massachusetts Route 116 North, Plumtree Road intersection, damaged white pine

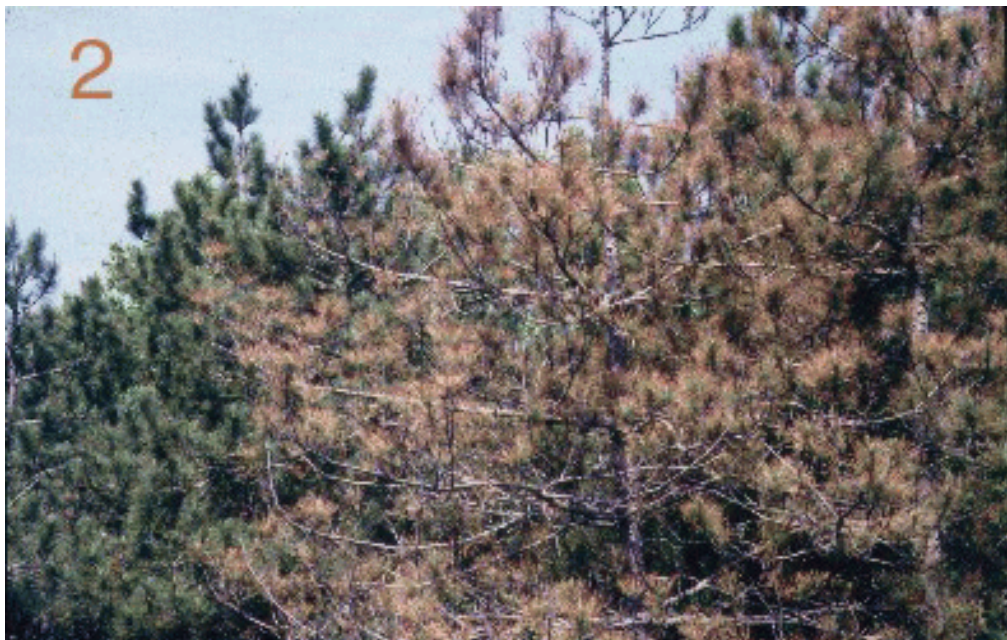
2. Massachusetts Route 2 East, Exit 31b, damaged white pine

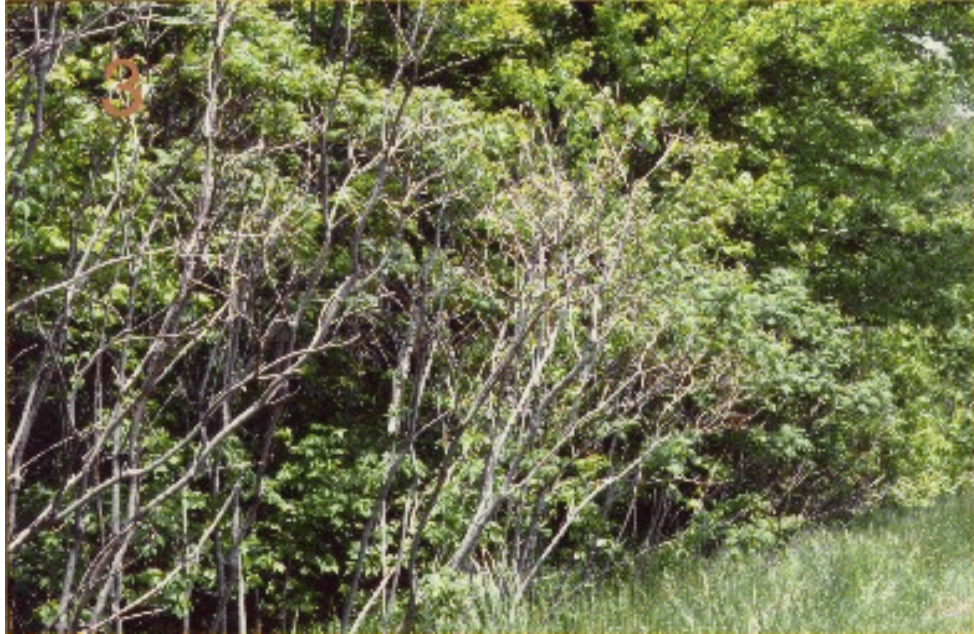
3. Massachusetts Route 2 West, Exit 30, damaged sumac

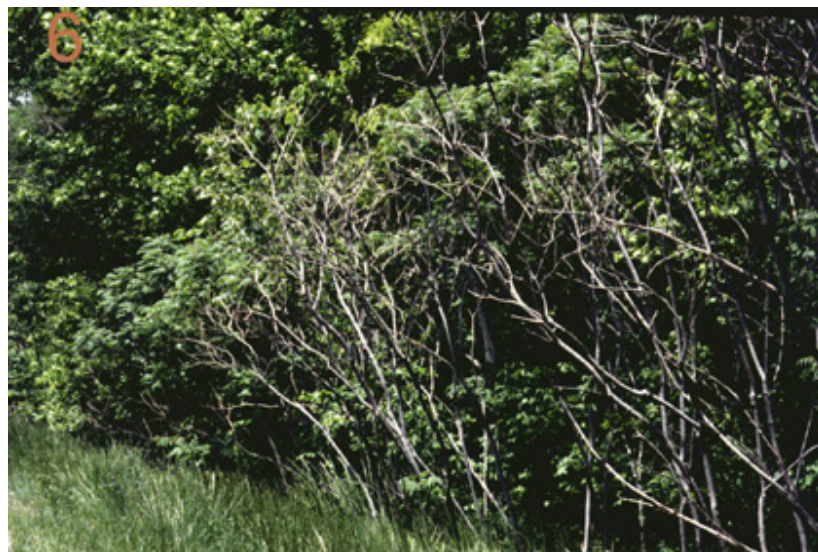
6. Massachusetts Route 9 West, mile marker 16, damaged sumac

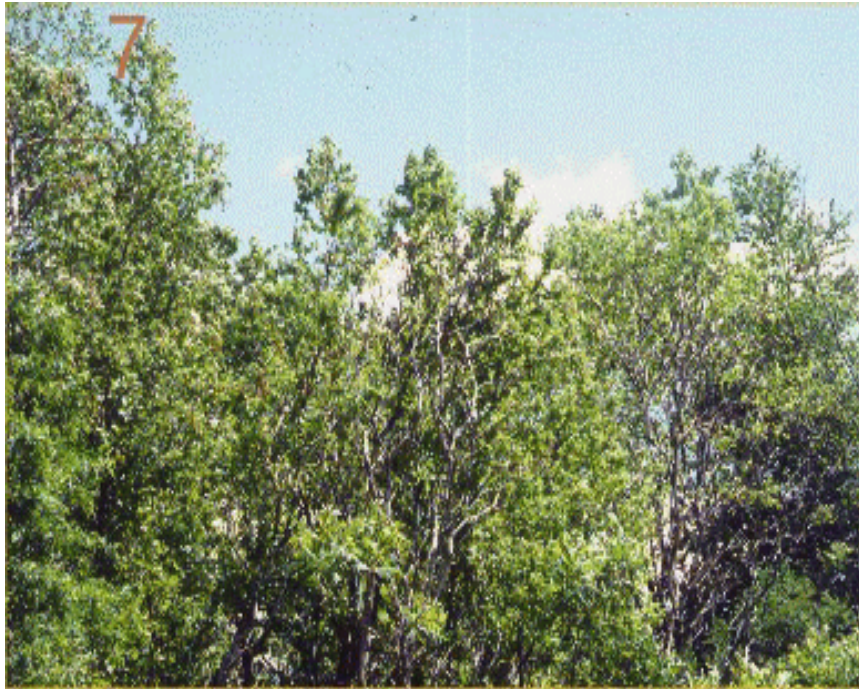
7. Interstate 91 North, mile marker 115, damaged sumac

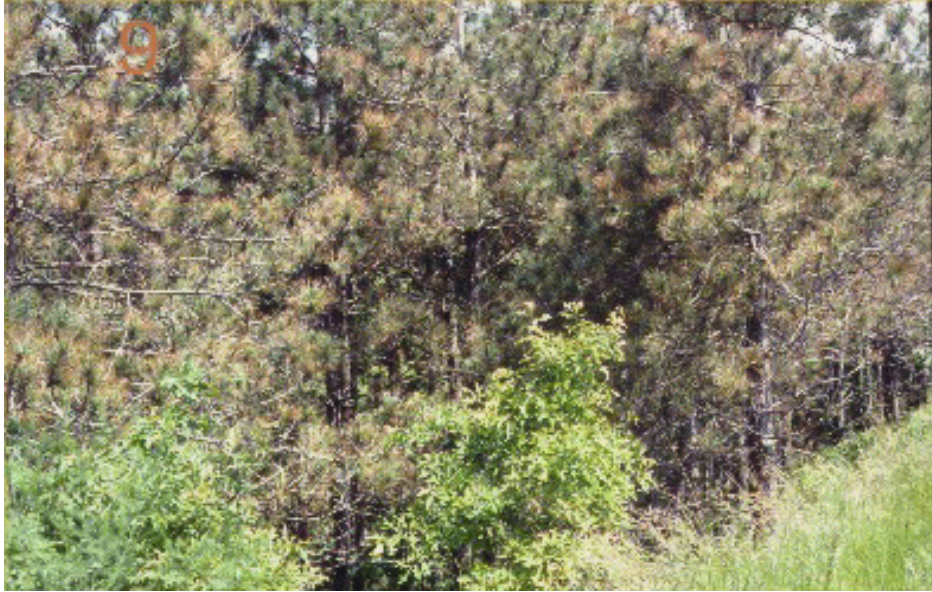
9. Interstate 91 South, mile marker 18, damaged pine

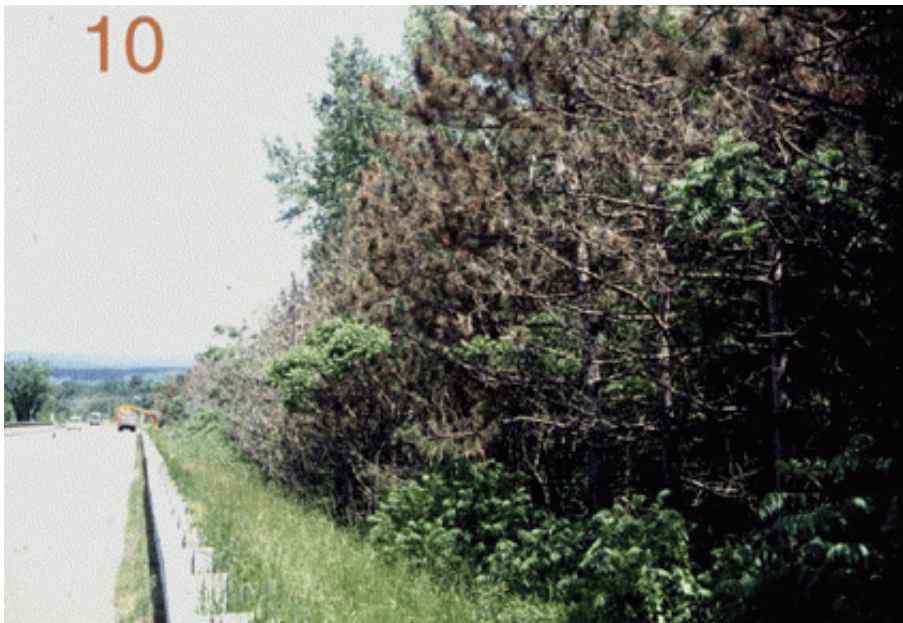
10. Interstate 91 South, mile marker 21, damaged black pine (with Diplodia)

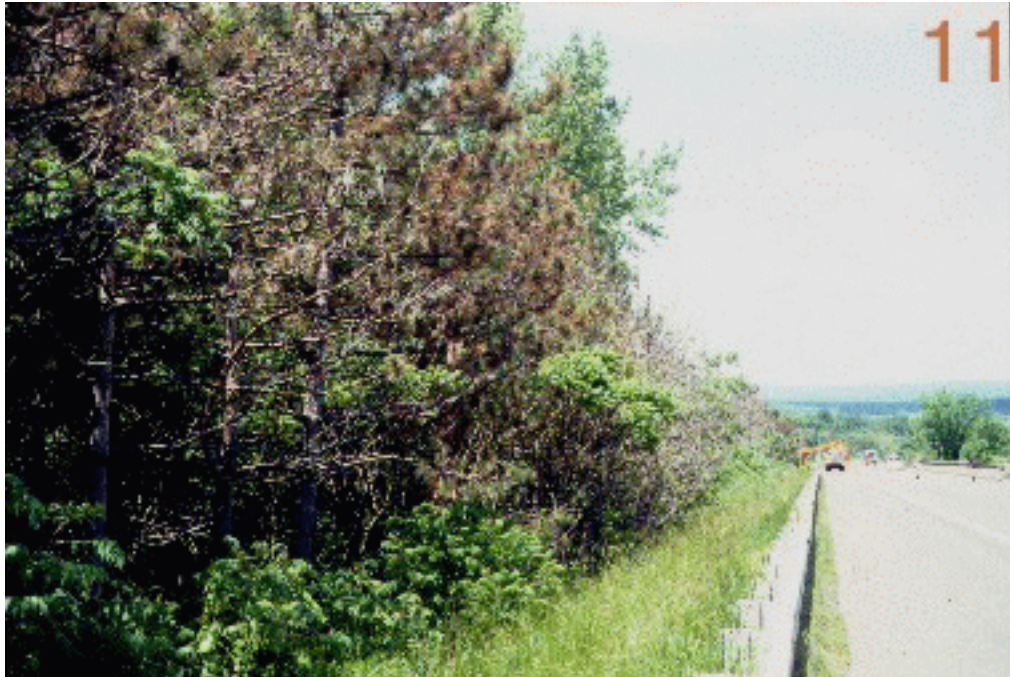
11. Interstate 91 South, mile marker 21, damaged black pine and damaged sumac

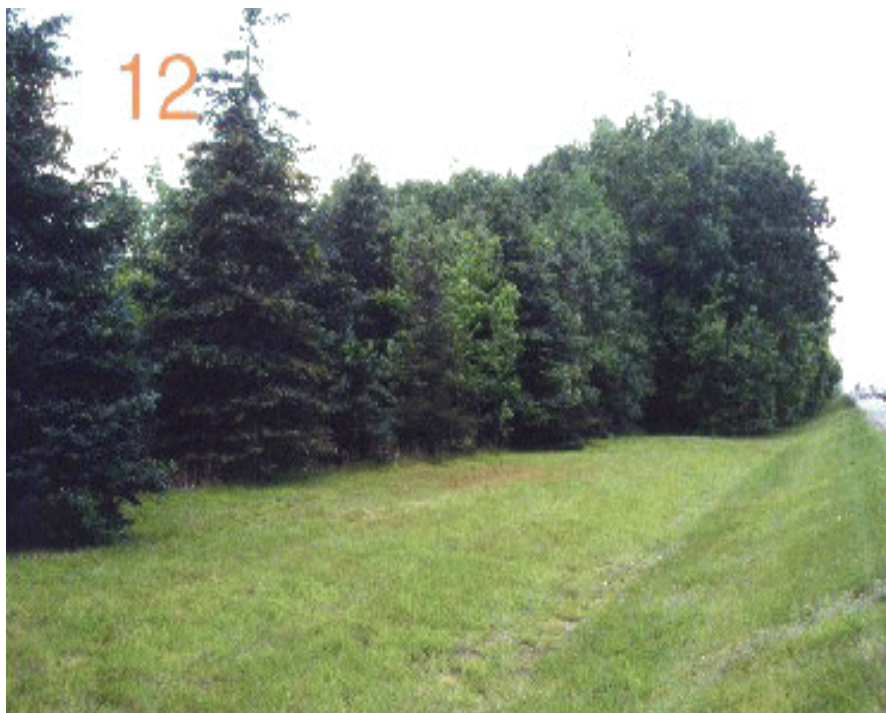
12. Interstate 91 South, mile marker 29, damaged spruce and grass
